# CINS Recommendation Paper - IMDG SP188 Lithium-Ion Batteries

A Publication of CINS, the Cargo Incident Notification System

## Annex - Photo Evidence Extracted from the CINS Incident Data from 2024 onwards

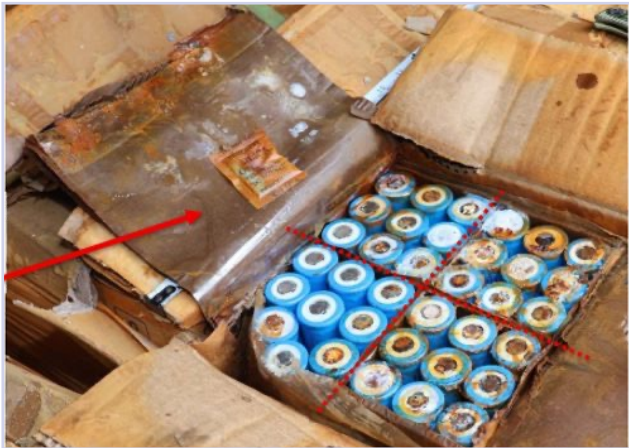
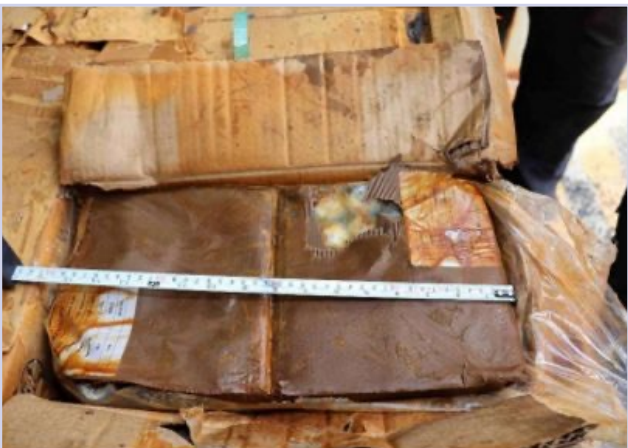
| View of cargo was found in burnet condition/cartons were torn condition/Cut condition | View of verified cartons/cargo which was matching as per documents |

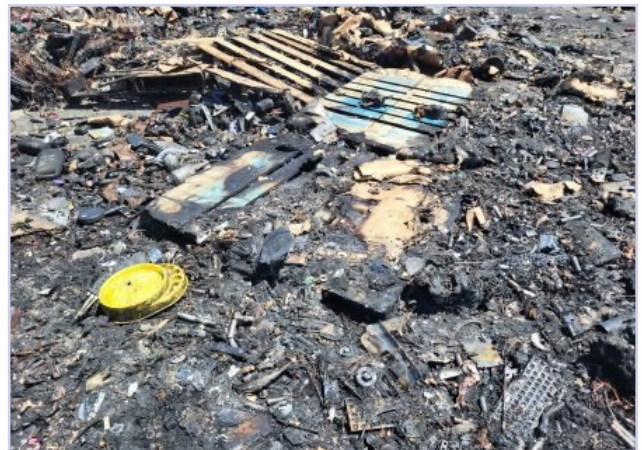
11. The view of the small batteries type 18650 in damaged condition was scattered in the damaged Container No. EGHU 8316805.

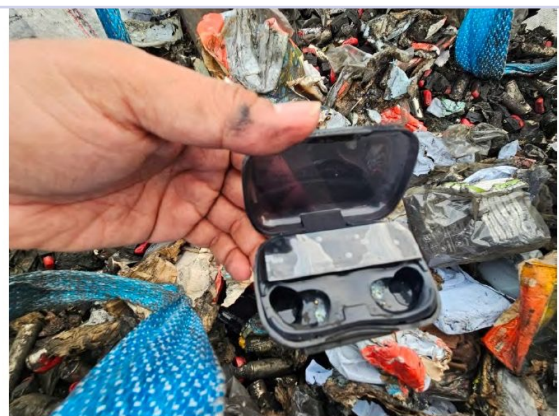
20. The view of TWS (True Wireless Stereo) one of the cargo found damaged and melted.
