May 2026

CINS Guidelines for the Carriage of Cocoa Butter in Freight Containers

A Publication of CINS, the Cargo Incident Notification System

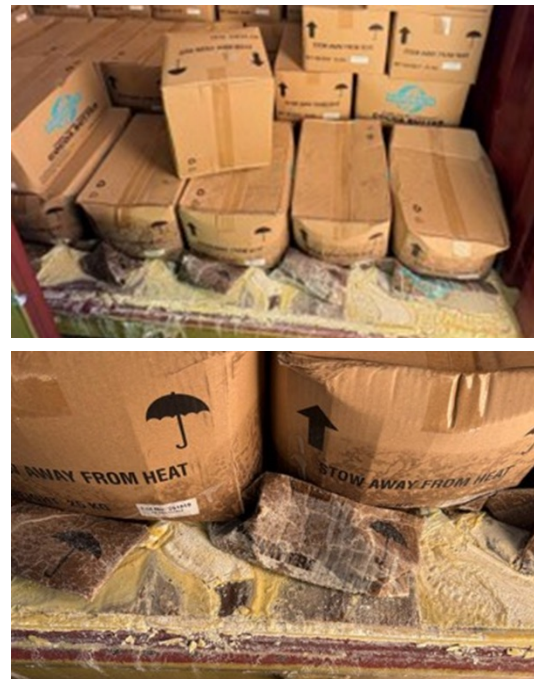
Leaking packages

Upon heating, cocoa butter expands and may cause it to burst the packaging and seep out, staining adjacent cartons (see **Appendix II**) and possibly leaking outside of the container or causing damage to the container structure. There have been incidences of cocoa butter melting on board ships, resulting in the clogging of ships' bilges. The figure below left shows a ship's cargo hold bilge well clogged by melted cocoa butter stowed under deck.

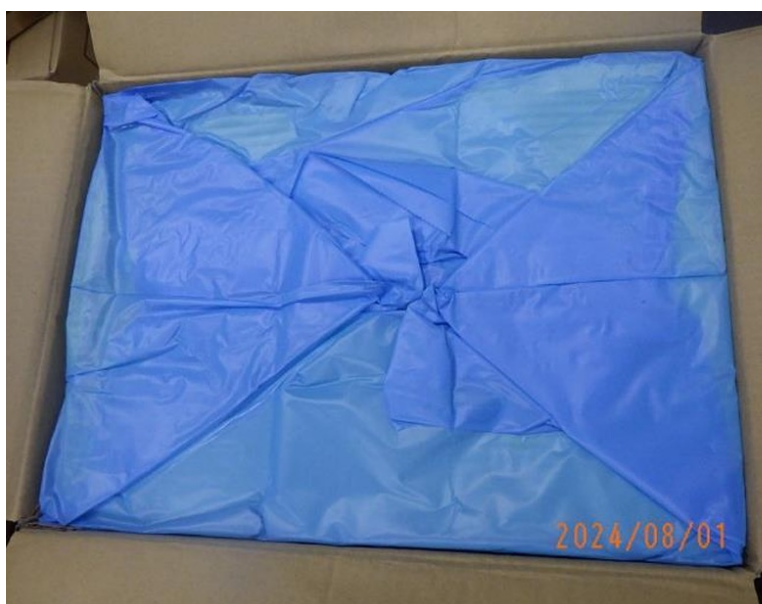
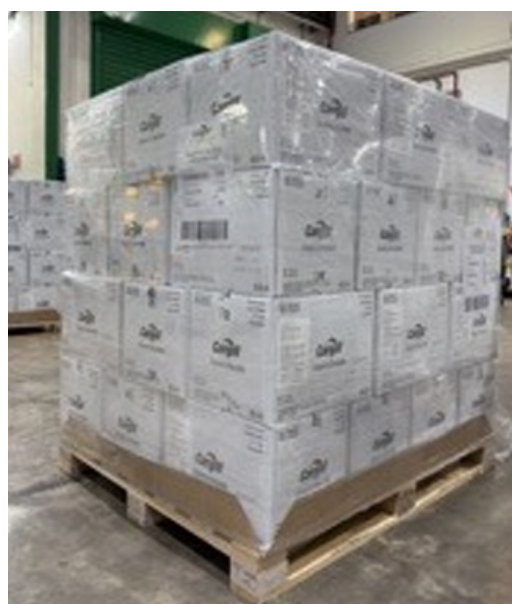
Illustrations 3.1: Typical inner and outer packaging

Cocoa butter shall be packaged in sealed plastic bags and placed within robust cardboard cartons. When transported in dry containers, it is imperative that the cartons are engineered to withstand the total stacked weight, including scenarios in which the cocoa butter may soften due to elevated temperatures. A standard packing method involves placing 25 kg blocks in sealed bags within cartons measuring 40 × 30 × 25 cm. In a 20-foot standard container, up to 800 cartons may be stowed, typically in 8 tiers, resulting in a gross container weight of approximately 22 tons. Stack heights must not exceed the load-bearing capacity of the bottom-most cartons.

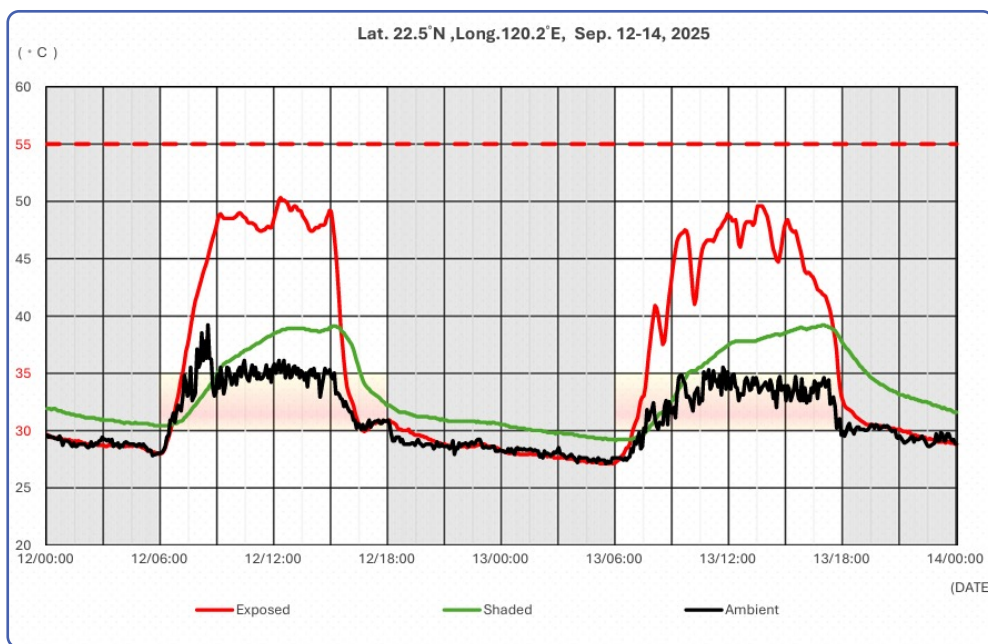
1. Direct Sunlight Effect: Exposed to vs. Shaded from

Graph: The red line represents a container stowed at an exposed-to-direct-sunlight position, the green line represents a container stowed at a position shaded from sunlight, and the black line represents the ambient temperature in the adjacent area to these two containers.

This graph shows a 48-hour record. It explains why containers carrying heat-sensitive cargo, such as cocoa butter or other hazardous cargo, should be stowed away from direct sunlight and other heat sources during transportation, whether on land or at sea. It also indicates the differences in how temperatures inside a container interact with the ambient during the daytime with sunlight and at night.

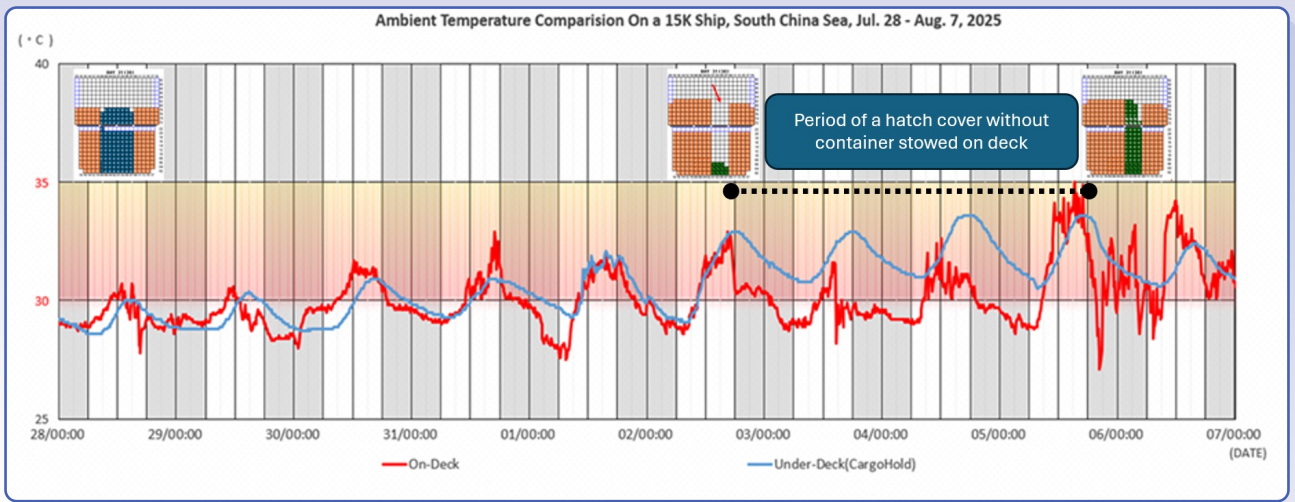
3. Exceptional Warm Period When Stowed Under Deck

This ten-day ambient temperature graph of on-deck vs. under-deck was recorded from July 28 to August 6, 2025, on a 15,000 TEU vessel navigating the South China Sea, contrasting the ambient environment difference if containers stowed on deck with the others positioned under deck in the cargo hold away from heat sources

Graph: The red line represents the on-deck ambient temperature, the blue line shows the cargo hold temperature (under deck).

It is worthwhile to note that during the period, as the black-dash line indicates in the graph, a hatch cover without containers being stowed on top of it, the hatch cover becomes heated by the sunlight during daytime, as a consequence, the cargo hold ambient (under-deck stowage positions) turns out to be much warmer than on-deck, even without a heat source in the cargo hold. Under such circumstances, heat-sensitive cargo stowed under deck may be adversely affected.

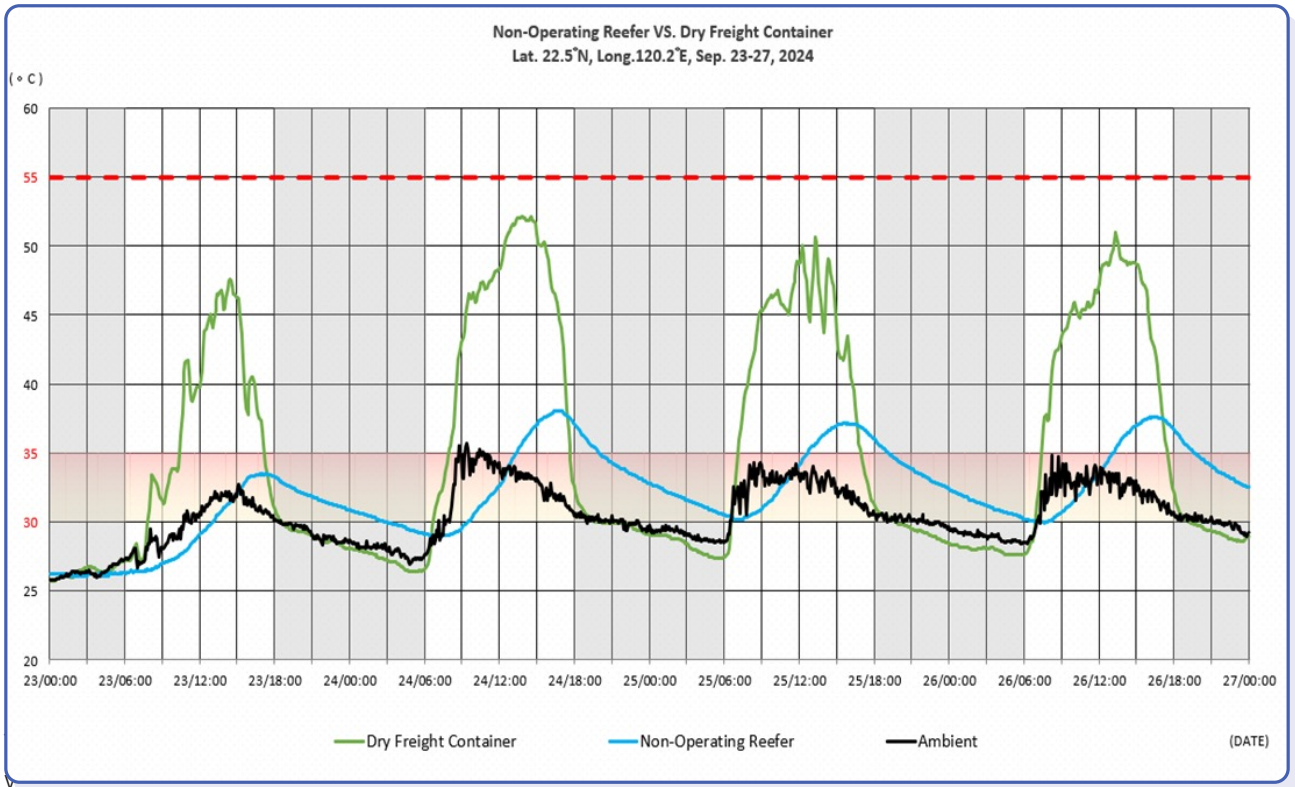
4. The Heat Accumulation Phenomenon inside a Non-Operating Reefer

The following was recorded at a marine terminal in Kaohsiung over the period 23-27 September 2024. The blue line shows how the temperature cycle inside a non-operating reefer is impacted by heat accumulation. The black line represents the ambient temperature, and the green line shows the internal temperature change of a nearby standard freight container.

The graph shows the difference in temperature accumulation between a non-operating reefer container and a dry freight container. The dry freight container absorbs significantly more heat during the daytime than the non-operating reefer; however, it loses most of this heat during the night, and its internal temperature drops to a level close to the ambient temperature.

In contrast, the non-operating reefer container accumulates heat more gradually and to a lower peak temperature during the day. However, once heat is accumulated, it is retained for a longer period, resulting in a slower and relatively smaller reduction in temperature during the night.

When a non-operating reefer container is considered, the potential for heat accumulation inside the container must be carefully evaluated. The heat accumulation phenomenon, which can lead to elevated internal temperatures during transit, is explained in **Appendix I (Section 4)**.

As stated in section 2.3, when considering the use of non-operating reefers, heat accumulation must be taken into account.

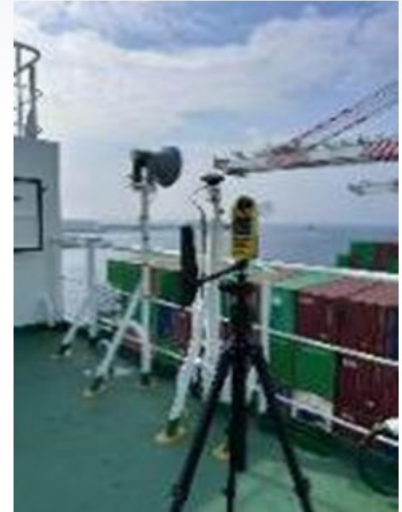
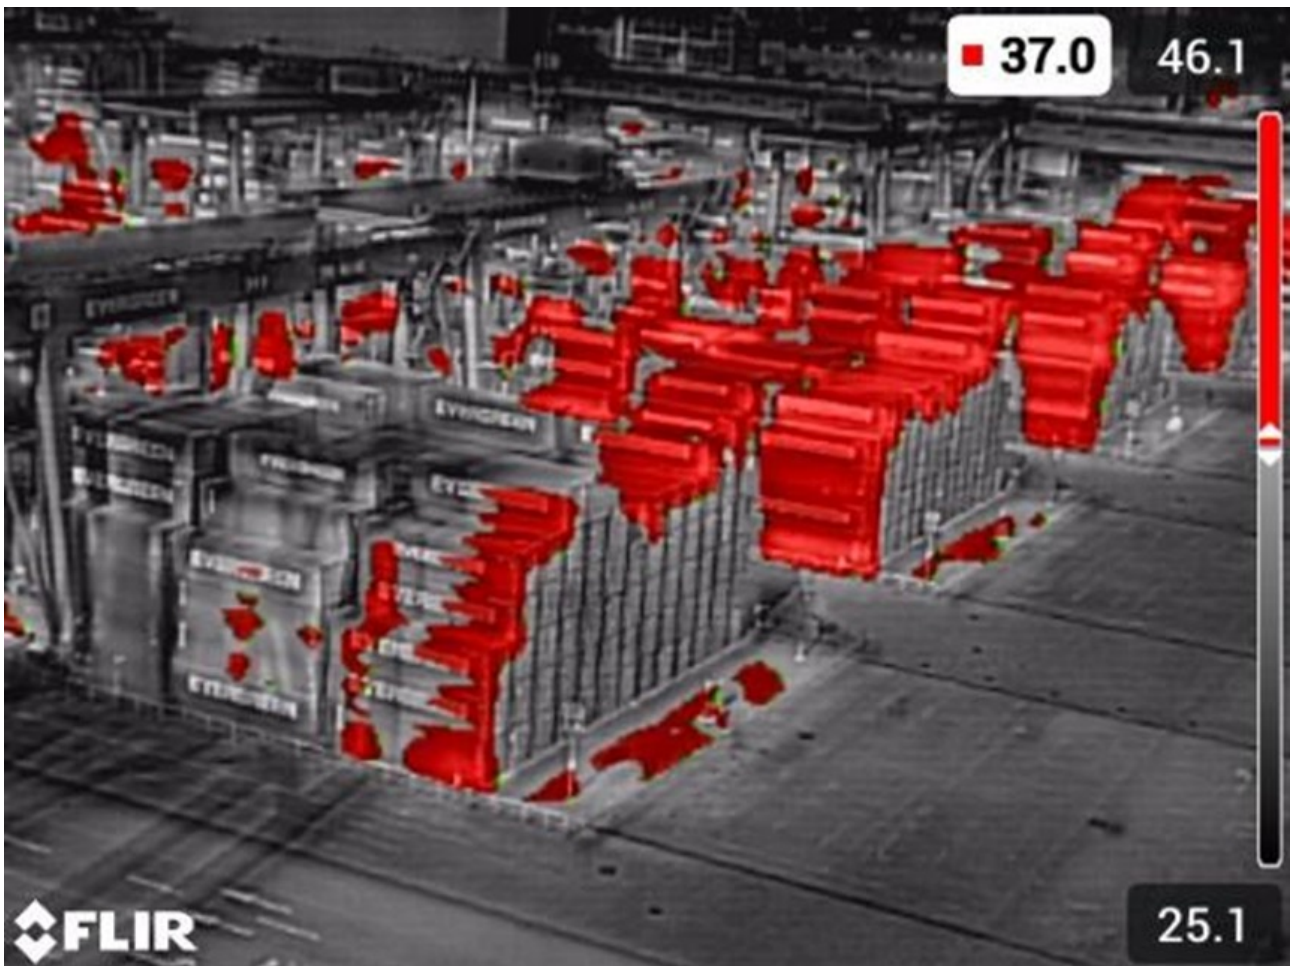
5. Thermal Imaging Observation

A thermal image taken at the marine terminal shows that the surface temperature of dry freight containers may exceed the melting point of cocoa butter (37 °C), reaching up to 46.1 °C. The photograph was taken on January 15, 2026, at Taipei Port. At the time of observation, the average daytime ambient temperature was 22.8 °C, and the average wind speed was 7.1 kt.

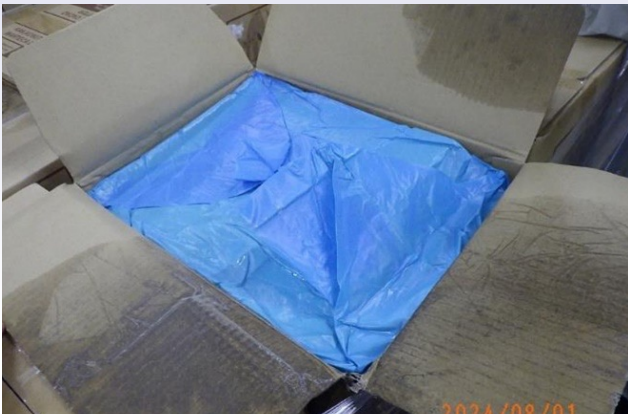
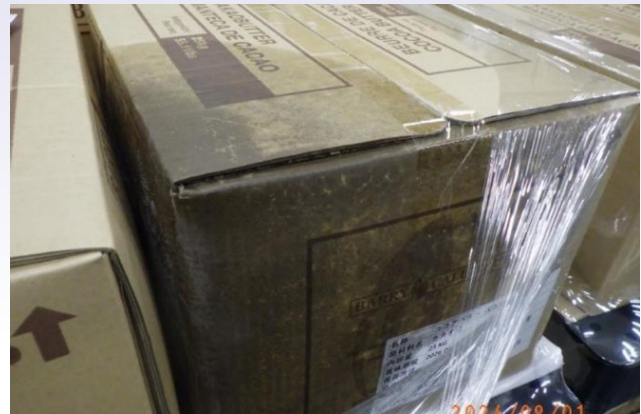
1. A typical cargo damage case: The following illustrations show the cocoa butter shipments damaged by high ambient temperature during transportation.

As illustrated in **Appendix II**, the quality of cocoa butter shipments may be significantly affected during terminal dwell time when ambient temperatures reach 30 °C or higher. The Appendix presents an overview of a cargo damage case involving a shipment exported from Malaysia, transhipped via Taiwan, and delivered to Japan during the summer season.

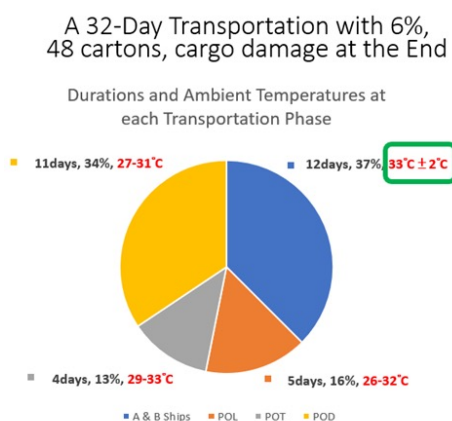
It was a 32-day voyage, starting from gate-in at the port of origin, via a transshipment port, to the port of discharge. The ambient temperature during the shipments' stay at the terminals was generally warmer than during the period on the ships.

Sea conditions on both legs of the voyage were relatively calm, indicating that the ship's motions were unlikely to be the primary cause of the carton damage. During the 32-day journey, containers spent 12 days—approximately 37% of the time—stowed under deck and away from any heat sources on both legs, an environment considered free from radiant heat, with container internal temperatures estimated to remain within the 31–35 °C range.

For the remaining 20 days, or 63% of the journey, containers were at three marine terminals. In these locations, internal container temperatures could exceed 50 °C (and potentially reach 70 °C or higher) for about 10 hours per day if exposed to direct sunlight or exceed 35 °C (up to 40 °C or higher) due to radiant heat when positioned in shaded areas protected from direct sunlight.

Referring to the temperature dataset in Appendix I, this cocoa butter melting was very likely to have occurred during the period spent at the three (3) terminals. As stated in section 4.1 Terminal Operations, it is advised that both shippers and carriers take feasible prevention actions to avoid long terminal dwell time to minimize the risk of cargo damage.

The illustration below is a recap of this cargo damage case for the reader's review.
